TRACES OF THE TOHOKU REGION GREAT TSUNAMI BEHIND A COASTAL FOREST

Key Words : *tsunami, Tohoku Region Tsunami, coastal forest, driftwood, pine tree, tsunami run up*

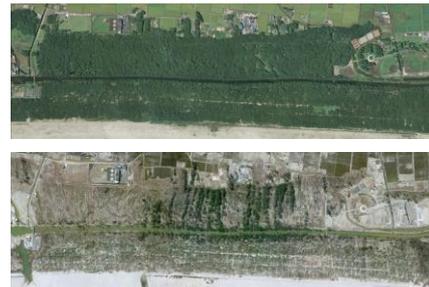
Figure 1 Location of the study area.

Figure 1 shows the location of the coastal area of Sendai City, Miyagi prefecture, as the field of analysis (all of the aerial photographs used in this study are based on Google Earth). Figure 2 shows the tsunami inundated area (within the area indicated by the red solid line). Photo 1 shows a comparison of the coastal forest zone before and after the tsunami disaster. Most of the coastal forests expected to have a certain degree of barrier effect against the tsunami were swept away as seen in the photographs. The positions of the root of the outflowed pine trees and the axial directions of the tree trunks were read from the aerial photographs using GIS. An example of the analysis is shown in Photo 2 (right).

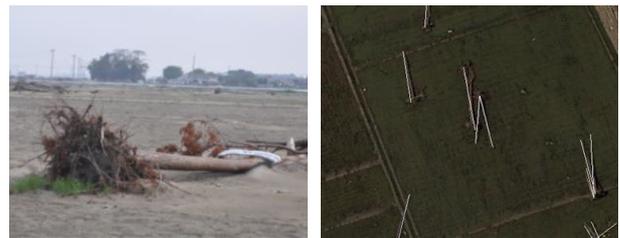
Figure 2 Inundation area of the tsunami.
